# SPLIT ROCK | Road safety evidence

Meeting handout • Drive recorded September 21, 2026 • Register snapshot September 23, 2026

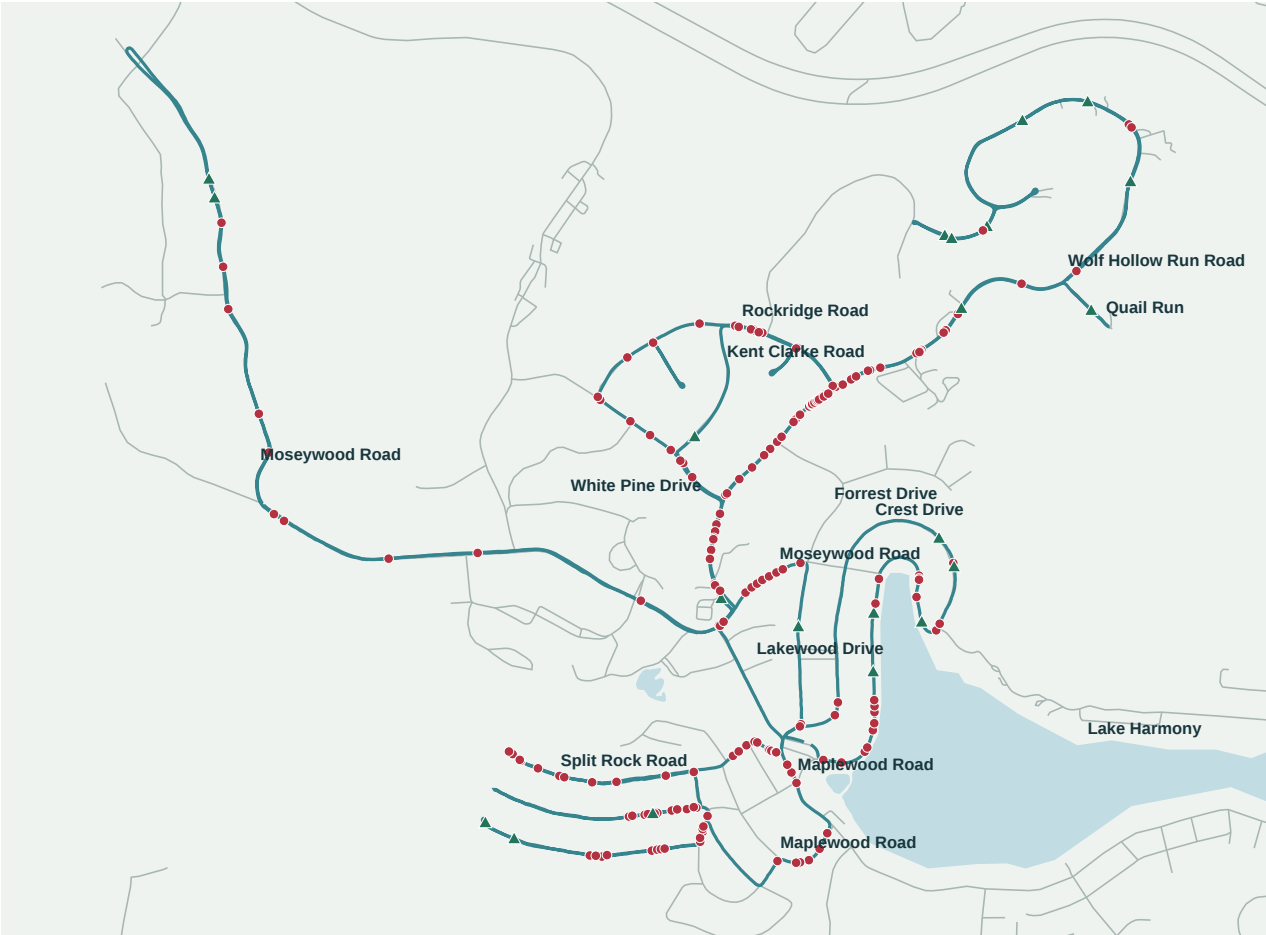
## WHERE CONDITIONS WERE RECORDED

Dots show selected pothole / pavement-loss candidates; triangles show vegetation candidates. Cracking, repair context and supporting evidence are omitted here to keep safety concerns visible. Markers can overlap.

- Red dot: pavement-loss candidate
- Green triangle: vegetation candidate
- Teal line: recorded camera route
- Gray line: mapped road

Colors identify evidence categories, not measured severity. In the app: ochre = cracking; orange = repair surface; purple = obstruction / parking. Squares include supporting evidence.
